Off-Highway Truck TA1

Inspectienummer	19890145	Klanten email	niels.van.dommelen@po n-cat.com
Serienummer	TNM00348	Werkorder	SCA044156
Maken	CATERPILLAR	Voltooid op	12-11-2024 13:10:13
Model	777G	Inspecteur	Geert Vosters
Uitrusting familie	OFF-HIGHWAY TRUCK	PDF gegenereerd op	12-11-2024
SMU	21547 Uren	Plaats	15 Dennenbos, Veldhoven, Brabant
coördinaten	28.4127082824707, 51.4141534709737, 5.37545120887708		
Technician

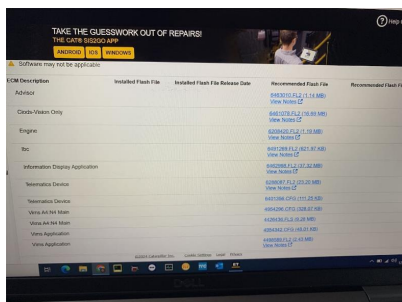
● **1.4 Is the machine software including Product Link & VIMS Config files current with what is published in SIS?** NO

Comments: Software niet up to date. Zie psr.

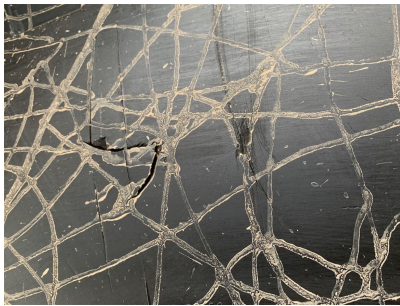
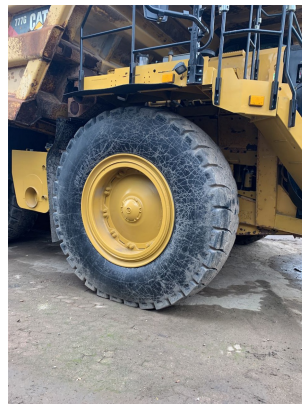
- 2.1 Tires and Rims MONITOR

Comments: Buitenwang band rechtsvoor beschadigd

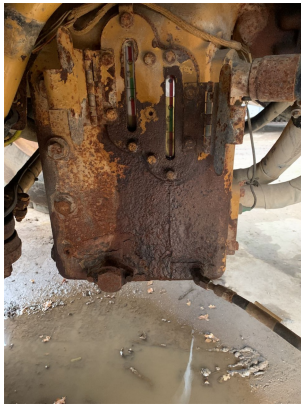
- 2.6 Transmission and Transfer Gears MONITOR

Comments: Lekkage bij niveau glas

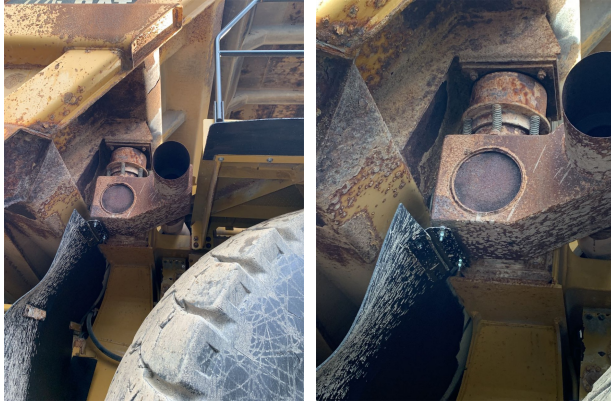
● **3.4 Exhaust Manifold**

Comments: Plaat gemonteerd aan binnenzijde. Eindeel uitlaatdemper ontbreekt

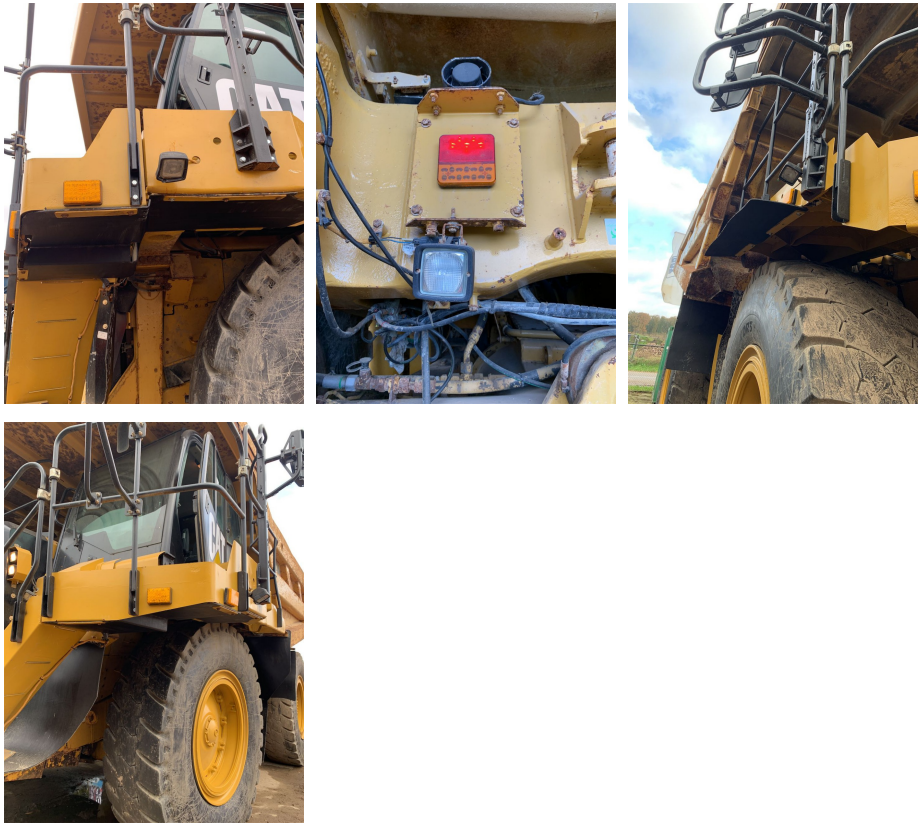
● **3.12 Work Lights**

Comments: Werklamp linker+rechterzijde bordes defect.
Linkerknipperlicht achter defect.
Knipperlichten voor werken niet

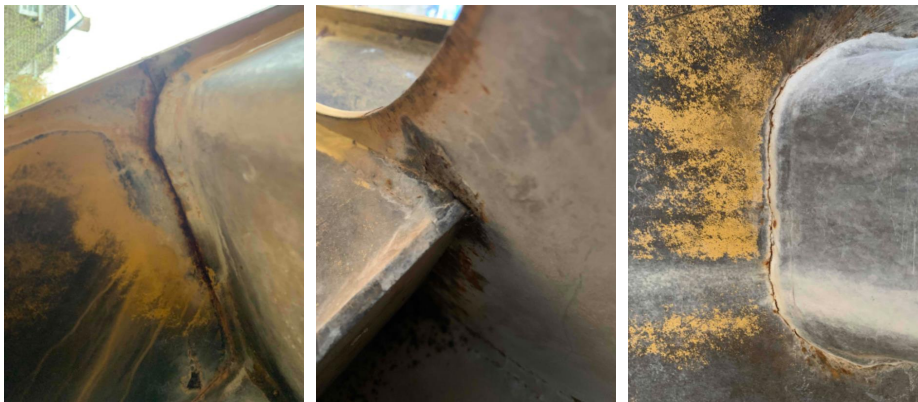
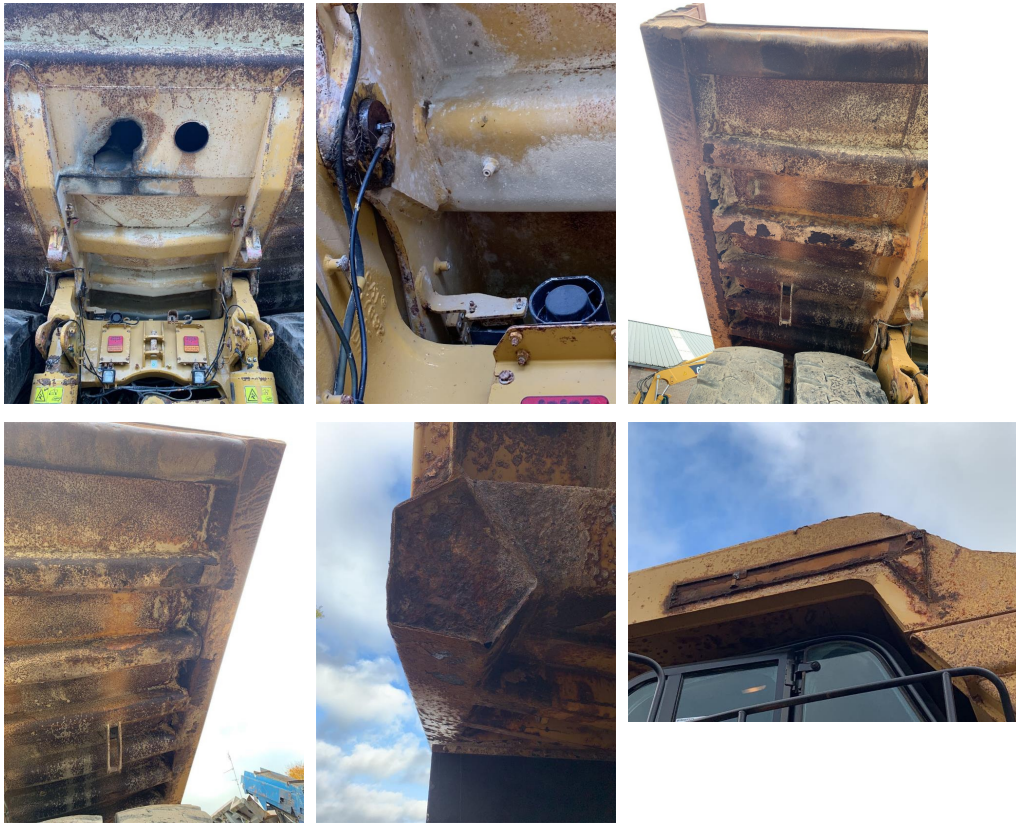
●	5.1 Hoist Cylinder	NORMAL
●	5.2 Truck Frame	MONITOR

Comments: Diverse scheuren en beschadigingen laadbak
